GEMINI DESIGN INFORMATION TEST PROGRAM

FINAL REPORT

85- AND 100-POUND-THRUST OAMS

THRUST CHAMBER ASSEMBLIES

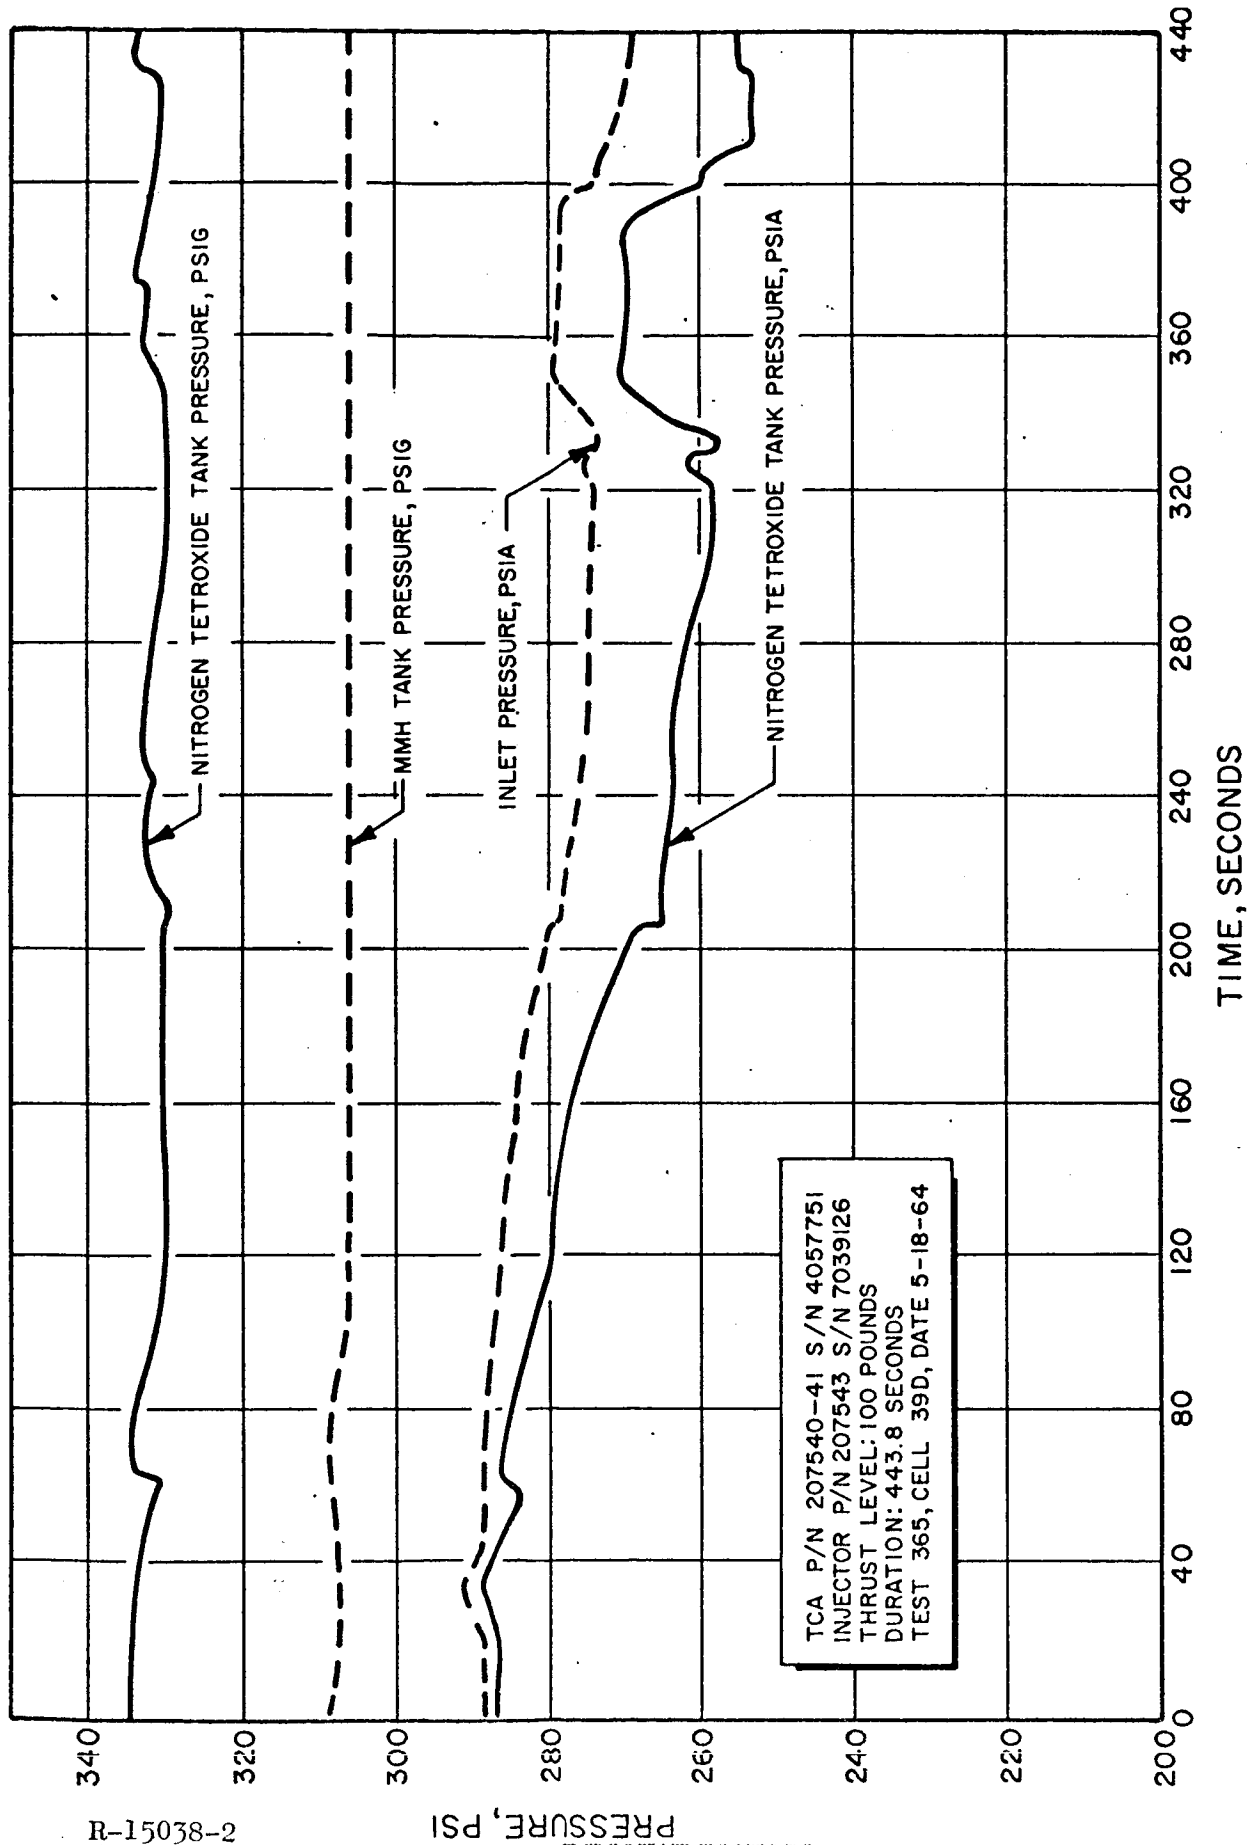
Figure 9. Pressure vs Time

Steady State Continuous Firing Test - The performance parameters at the start of the test were similar to the calibration tests. As the test progressed, thrust, chamber pressure, inlet pressures, and propellant flows changed as shown in Figures 8 and 9. Temperature of the TCA increased during the test as shown in Figure 10.

The throat started eroding gradually from 75 seconds to 170 seconds at which time part of the throat insert was expelled through the nozzle. The chamber pressure had decayed to 105 psia while the thrust had increased to 105 lbs from the initial thrust of 96.16 lbs. During the next 50 seconds the throat insert again gradually eroded until at 318 seconds the remainder of the throat insert and liner relieved. The temperature of the TCA injector surface during the first 318 seconds of the firing appeared normal, but at this time it started to increase at a very rapid rate, Figure 10. Also, at this time, the thrust chamber pressure and flowrate of the propellant dropped which was not normal as flowrates usually increase when the chamber pressure decreases. One possible explanation of this phenomenon was that the propellant was being vaporized in the manifold of the abnormally hot injector. Injector surface temperature reached 600°F after 388 seconds of firing time. The increased temperature of the splash plate no doubt initiated accelerated propellant combustion within the splash plate area resulting in burning away portions of the splash plate in line with the orifice pairs. Loss of the splash plate resulted in a changed injector burning pattern which in turn eroded the injector end of the combustion chamber and eventually burned through the TCA ablative, shell, and injector.

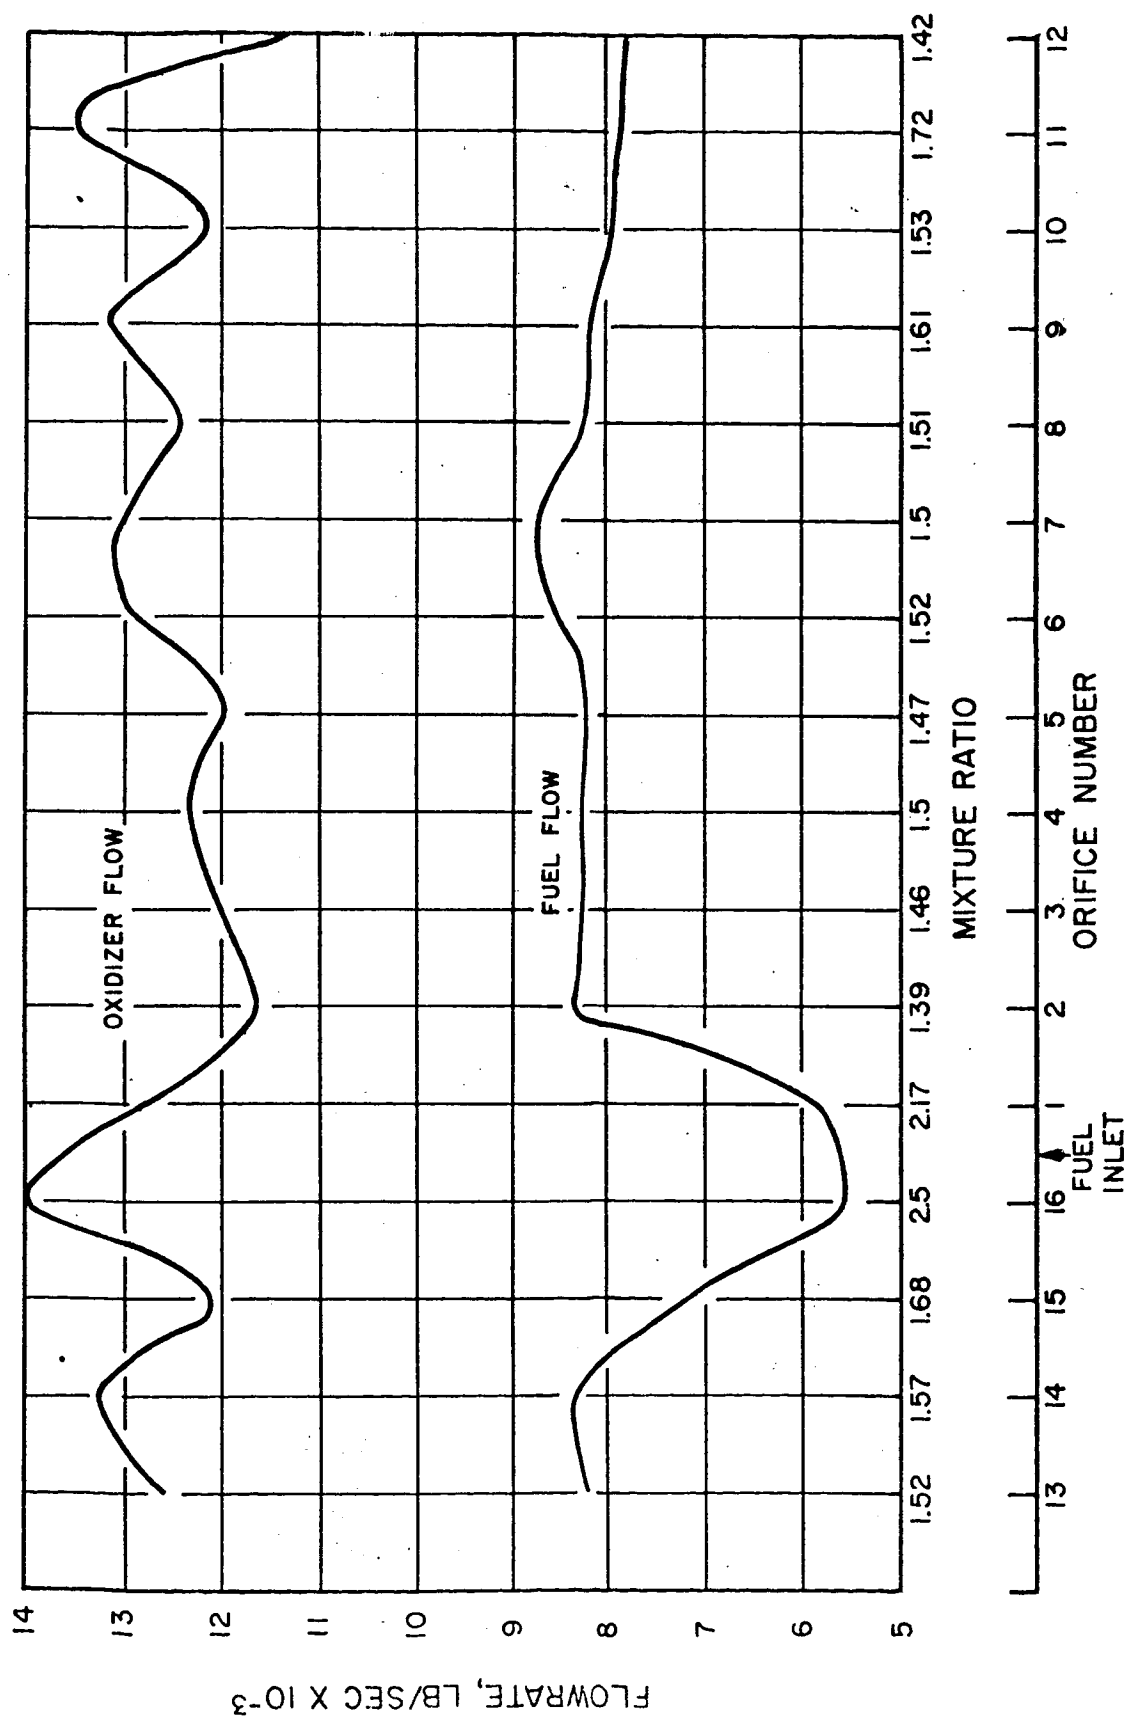
Figure 16. Fuel and Oxidizer Flow vs Orifice Number

The amount of water flowing through each oxidizer and fuel orifice was measured at total design flowrates. A plot of flowrate versus orifice location is presented in Figure 16. Mixture ratio for each pair of orifices was calculated for each of the 16 pairs and is also shown on Figure 16. The highest mixture ratio was 2.50 and 2.17 found at the orifice pair adjacent to the fuel inlet. This condition is normal for this type injector.

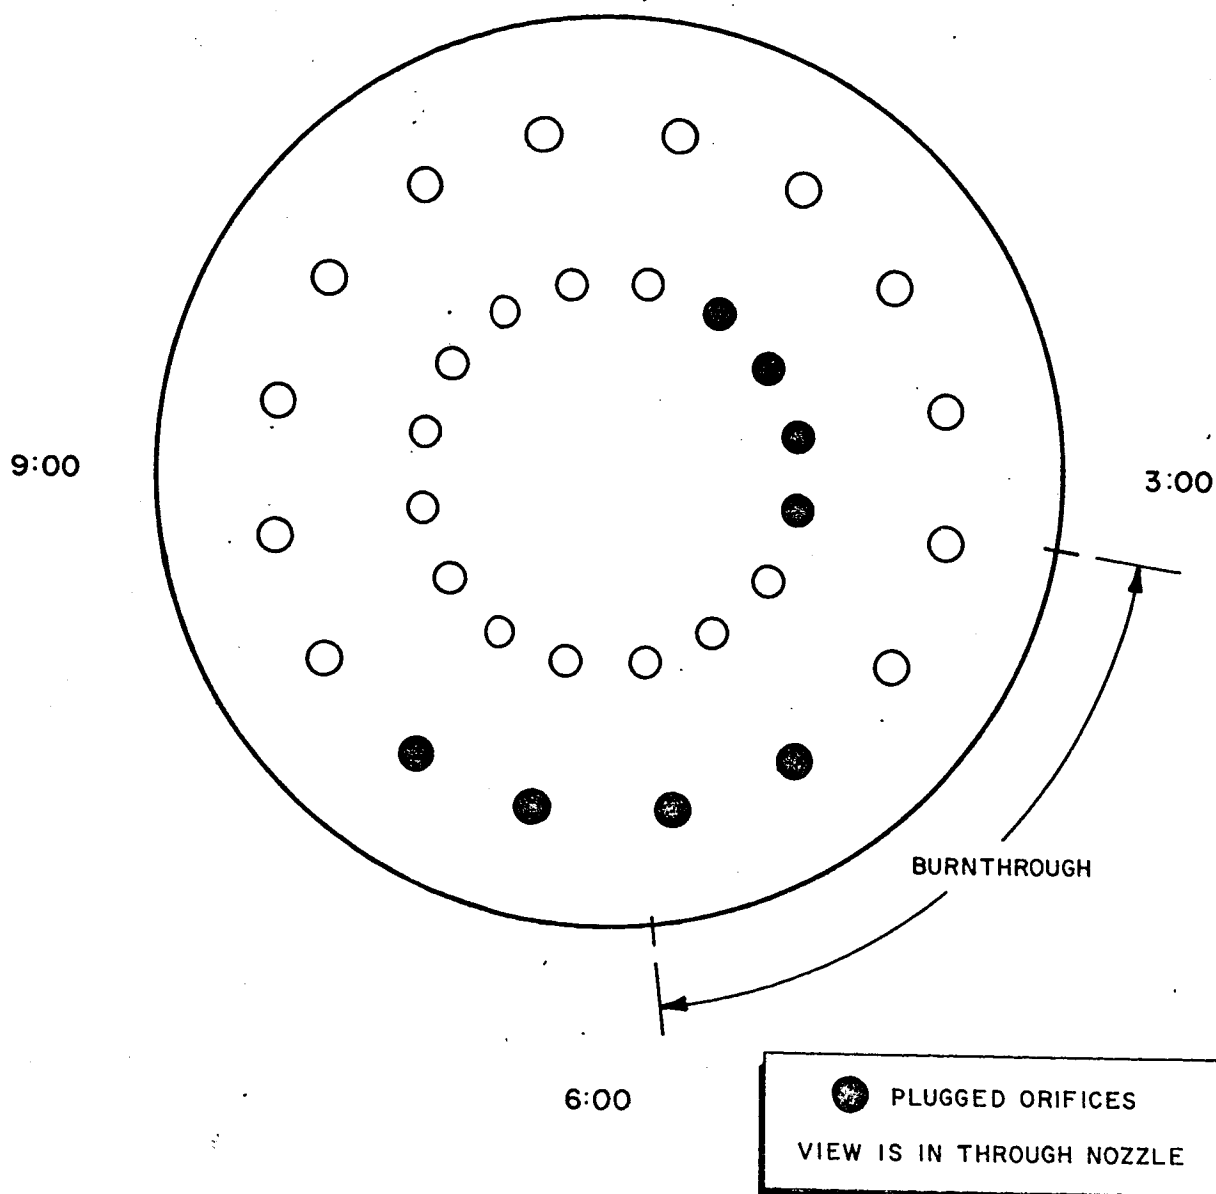
Figure 32. Plugged Orifice Locations

The plugged injector test was a test performed with four sequential oxidizer holes plugged and four sequential fuel holes plugged (nonimpinging). The two rows of plugged holes were on the same side of the injector separated by one pair of impinging holes (Fig. 32 of Appendix G). This was considered to be the most severe manner which the injector might be plugged. The test was run to determine what performance and physical effects would result from operating in this condition. The test was designed to evaluate a potential malfunction although it is almost out of the realm of possibility to have 25 percent of both oxidizer and fuel passages blocked in flight. The test is considered extremely severe.

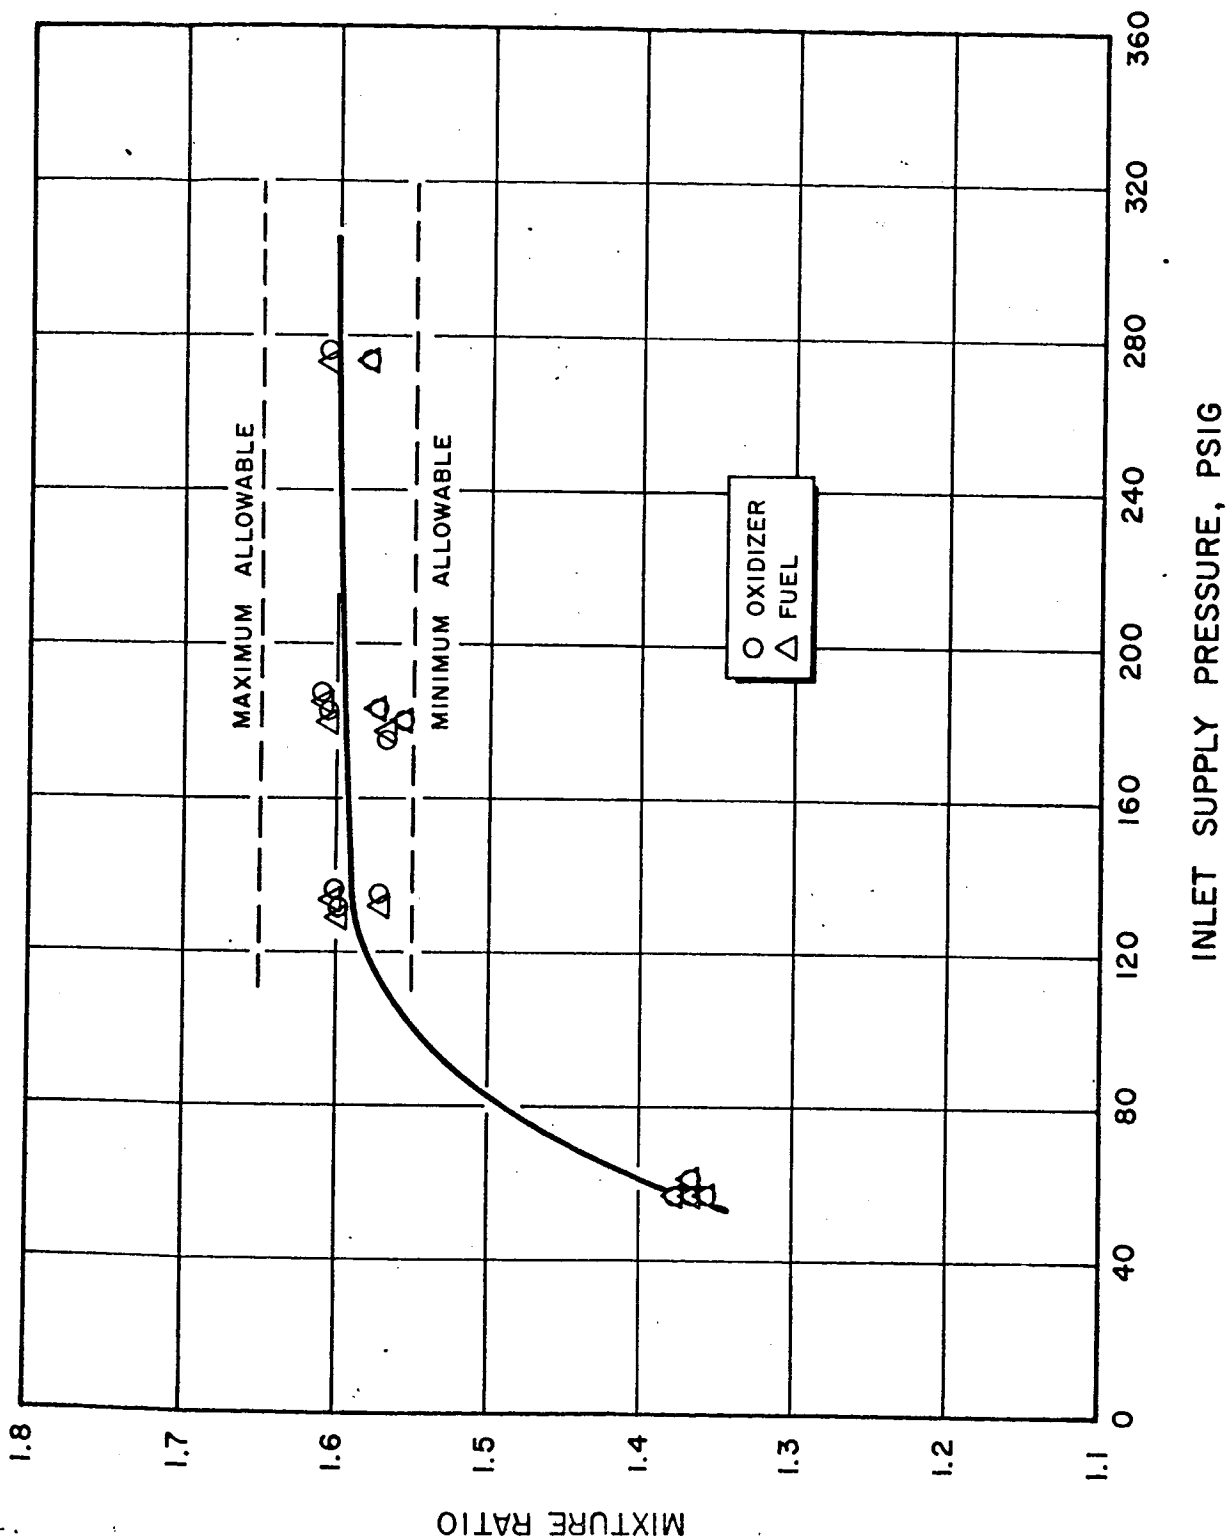
Figure 40. Mixture Ratio vs Inlet Supply Pressure, Low Supply Pressure DIT

The low inlet supply pressure design information tests show that engine performance was good for the calibration and the 75 and 50 percent tests at a mixture ratio of 1.6. A sharp decrease in performance (and mixture ratio) is evident at 25 percent of the inlet pressure. The first three liners at the injector end of the chamber were lost at the completion of the 25 percent tests. This has been attributed to the looseness of these liners which was evident prior to the start of testing. X-rays revealed no damage to the ablative portion of the thrust chamber. Total accumulated burntime on the thrust chamber is 201.6 seconds.

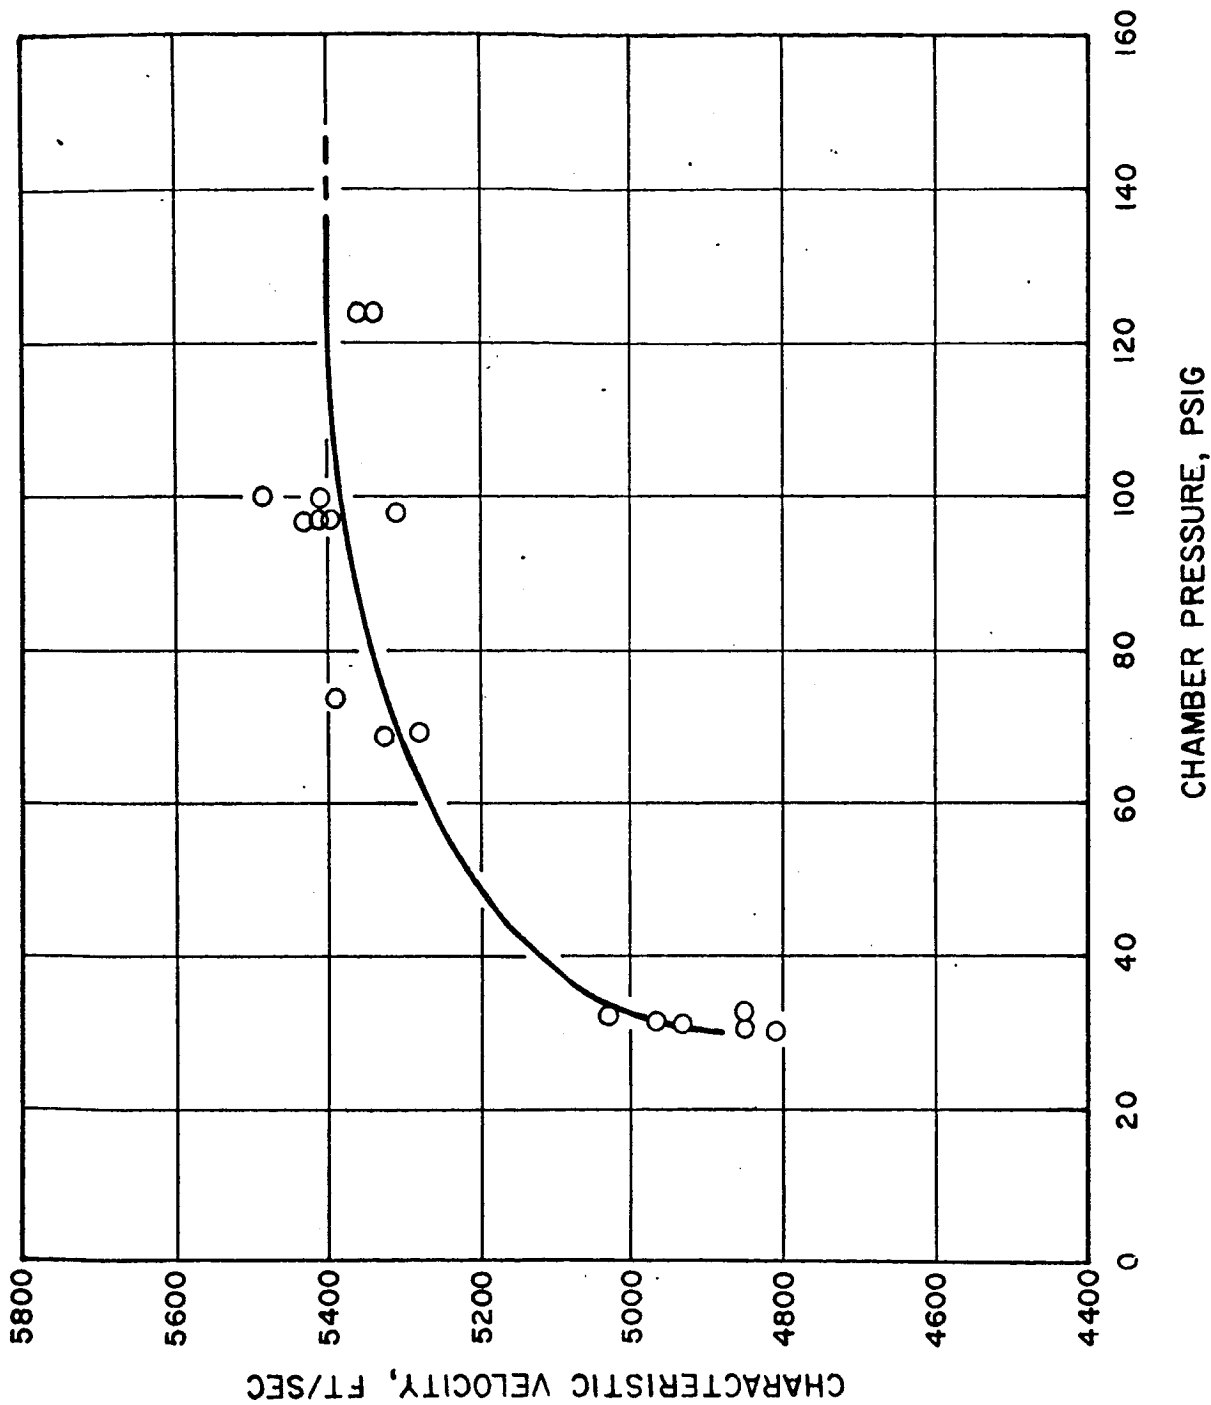
Figure 41. Characteristic Velocity vs Chamber Pressure,  
Low Supply Pressure DIT

ratio of 1.6. These tests were at a simulated altitude of 100,000 ft. while the low supply pressure tests were at ambient conditions. Performance for the 75 and 50 percent low supply pressure tests remained within  $\pm 2$  percent of the calibration test results but the efficiency for the 25 percent tests decayed to 85 percent (Figure 39). A mixture ratio of 1.6 was maintained for the 75 and 50 percent tests but dropped considerably (1.35) for the 25 percent tests (Figure 40). The inlet pressures were maintained at their respective percentage of design pressure within a tolerance of  $\pm 5$  psig. Figure 41 is a plot of chamber pressure versus characteristic velocity. The tests were conducted in a descending order of inlet supply pressure. The 75 percent tests were followed by the 50 percent and then the 25 percent tests. Upon completion of the 25 percent tests, the first three liners at the injector end were lost. Since only three of the 50 percent tests concluded in acceptable data, an attempt to repeat these tests was made but resulted in a marked increase in engine performance. This increase in performance is attributed to the change in burn characteristics at the head end of the chamber. Previous R&D tests on birdcage billets without liners have shown this tendency to have a higher performance but a shorter life. Audible screech was present during the 25 percent inlet supply tests. Valve response both on opening and closing was normal throughout the tests. Post test X-rays of the TCA showed the ablative body to be in excellent condition with no delaminations. The loss of the liners is attributed to their looseness in the chamber rather than as a result of the low supply pressure tests.
